CASE STUDY

# MORRISTOWN BRIDGE

Morristown, Vermont | 2002

The Morristown Bridge (BR 213) is located over Ryder Brook on Route 100 near Morristown, Vermont. The bridge is subjected to traffic of 7000+ vehicles per day.

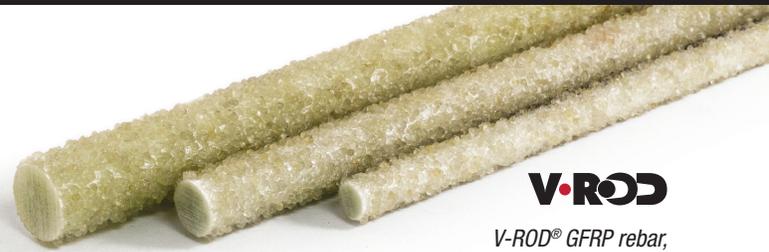
*V-ROD® GFRP rebar,  
available in multiple sizes*

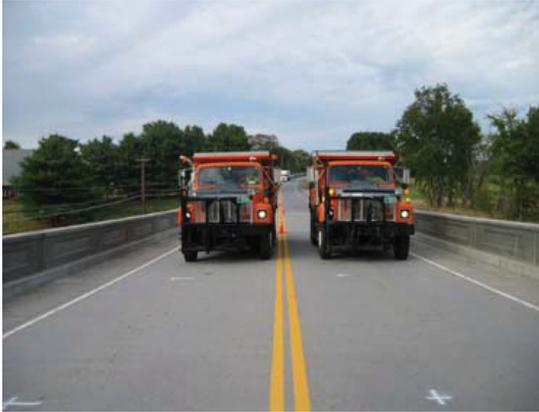
Field testing of the bridge

The bridge was tested for service performance (October 2003) under static loads using two calibrated truckloads with three axles each. Four paths, two in each direction, corresponding to the direction of each with seven stations (truck stops) were marked along the longitudinal direction of the bridge to give critical loading cases and influence lines at the instrumented section of the bridge (mid-span). The test was carried out using a single truck over the four paths and two simultaneously along one path such that the total of 35 (7 stations  $\times$  5 paths) readings were recorded for each gauge. The maximum value on the vertical axis represents the location on the bridge that contains the gauge under consideration (mid-span). For the single truck loading, the maximum measured strains in bottom and top GFRP bars were 31 and 4 micro-strains, respectively.
